HOME INSPECTION INC.

Site Location:
1234 Sample Lane
Your Town, Illinois 60000

Client:
Home Buyer

Inspection Date: ASAP

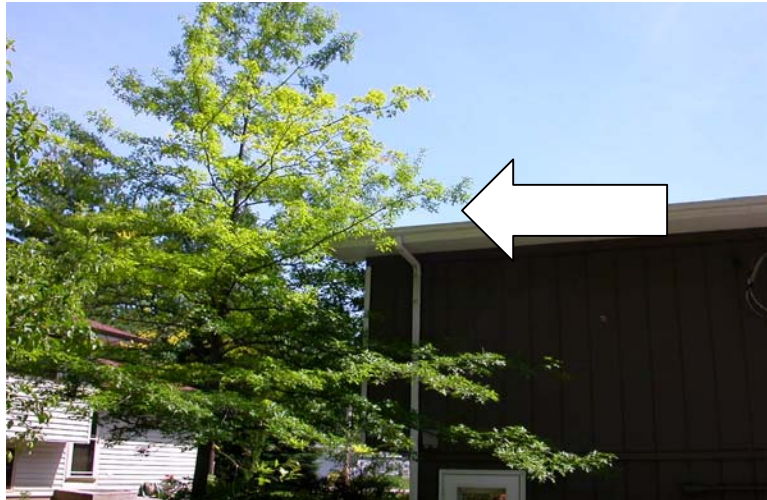
Vegetation: Trees, Shrubs
Conditions: **Overhanging branches** --- Overhanging tree branches are too close to the roof. Air circulation and sunlight help prevent deterioration of roof components. Recommend branches be trimmed back to alleviate this condition.

Rating: Maintenance Required

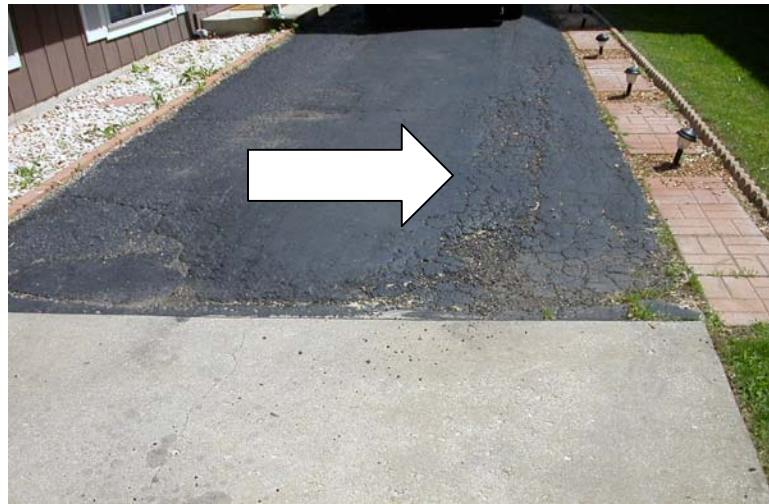
Driveway: Asphalt
Conditions: **Erosion noted** --- Soil erosion was noted and may need to be corrected.

Rating: Maintenance Required

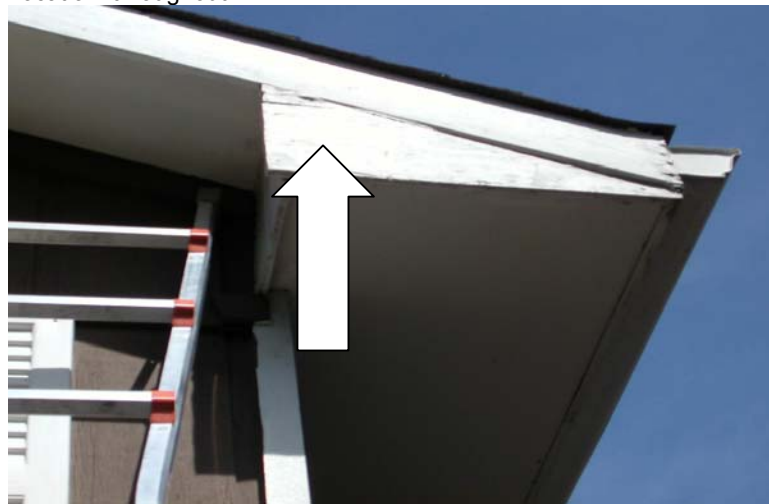
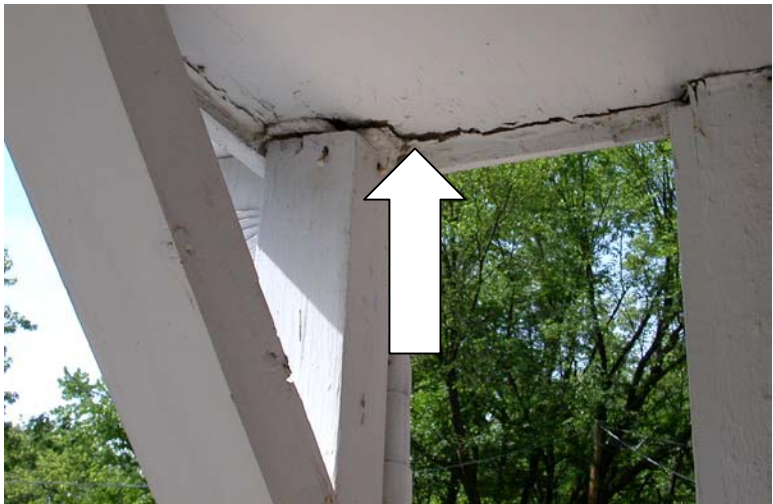
Trim: Wood
Conditions: **Wet rot** --- Wet Rot is the decay of wood in the presence of moisture and warmth, as a result of attack by fungi. This condition attracts insects. Eliminate the source of moisture then repair affected area.
Location: throughout

Rating: Maintenance Required

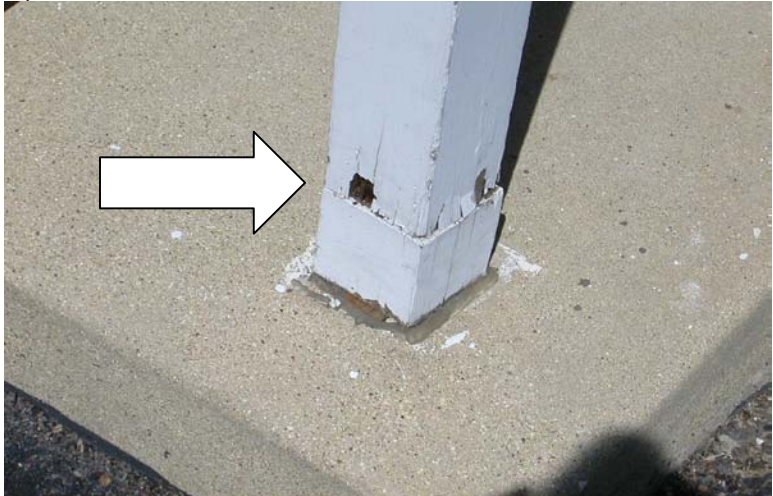
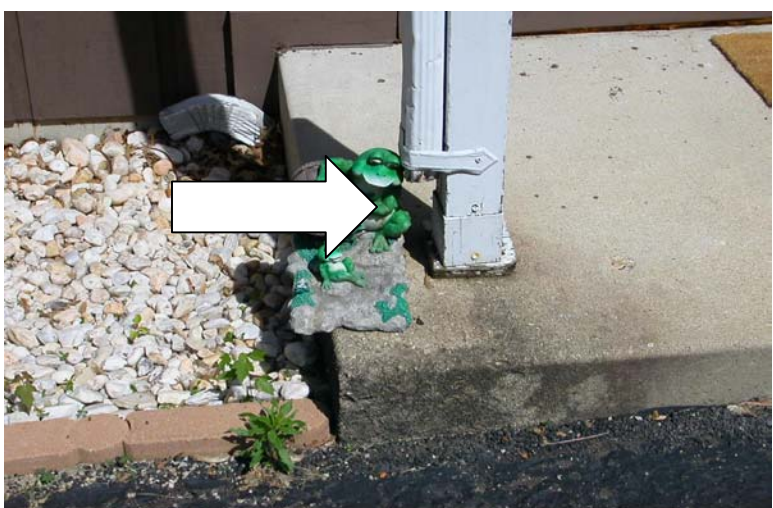
Dry rot --- Dry rot is decomposition in seasoned wood caused by fungi. Recommend repair of affected area as needed.

Rating: Defective

Condition: Dry rot

Defective

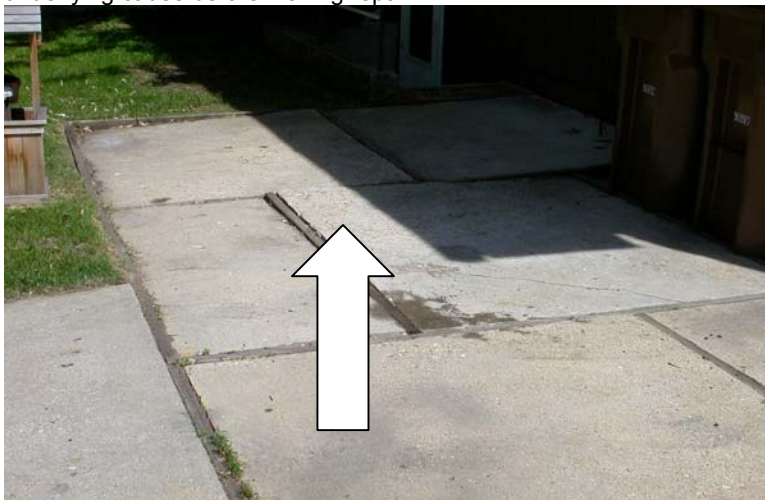
Concrete
Buckling --- Buckling was observed. This is caused by too much material in too little space. Either the material has swollen or the space for it has decreased. Determine the underlying cause before making repair.

Rating: Defective

Condition: Buckling

Defective

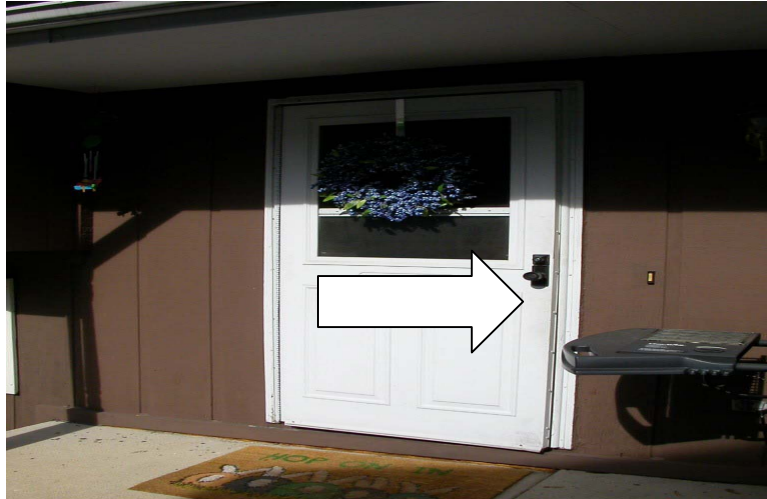
Storm Door: Vinyl
Conditions: **Physical damage** --- Physical damage was noted and should be repaired.
Location: Door would not close properly

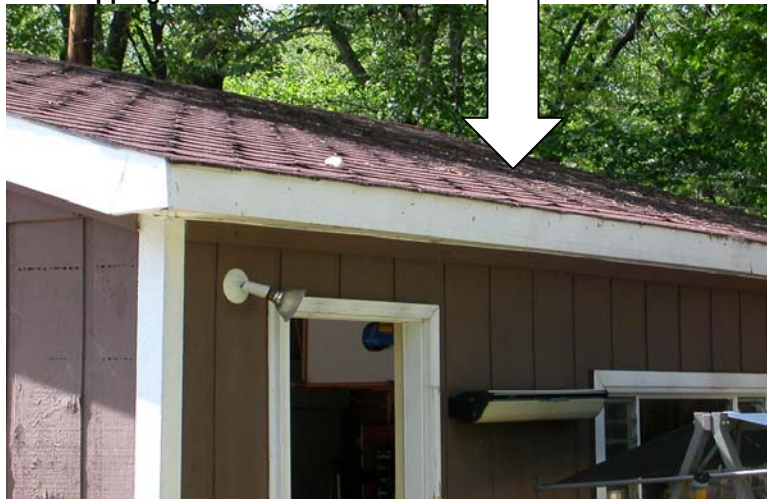
Detached Garage
Roof cupping ---

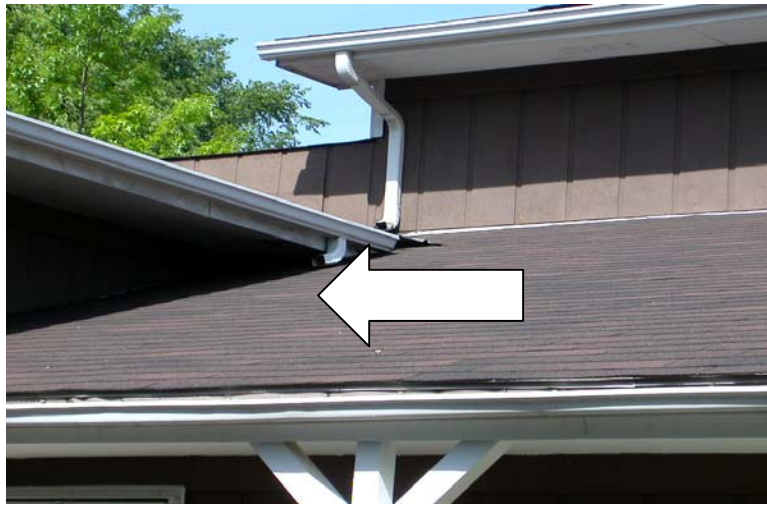
Type: Metal
Conditions: **Need cleaning ---** Gutters appear to need cleaning. Water could back up and cause damage if not corrected.
Gutter Extension ---

Rating: Maintenance Required

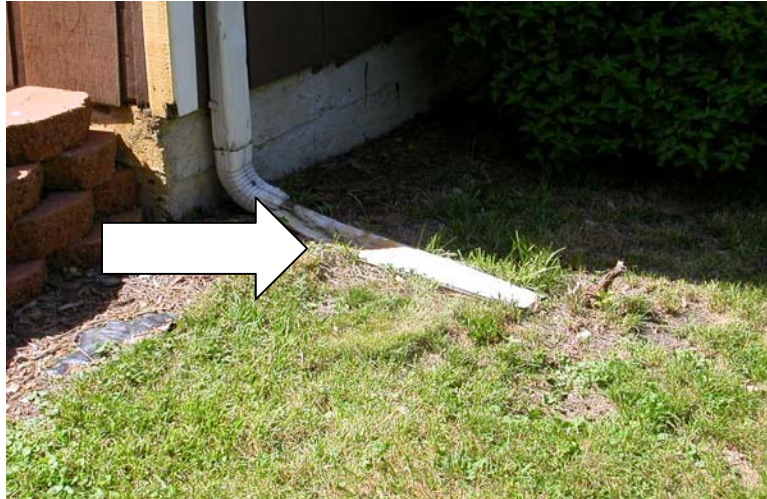
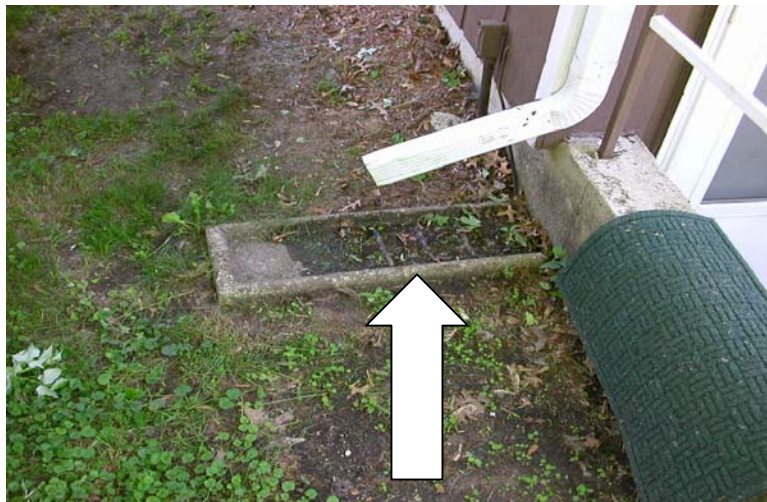
Down Spouts: Metal
Conditions: **Discharge near foundation** --- Downspout is discharging close to the foundation. This may cause water into the building. It is recommended that all downspouts be extended 3 to 4 feet from the foundation.

Rating: Maintenance Required

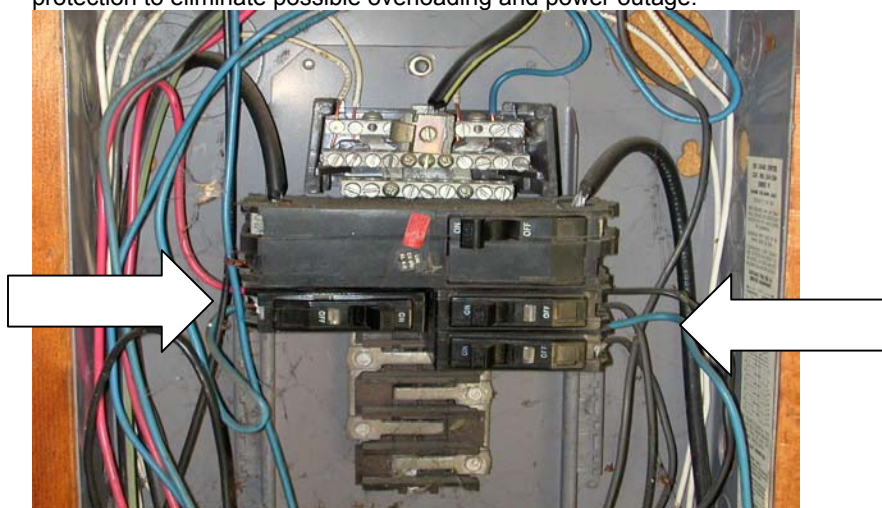
Type:
Conditions: **Double tap ---** Some circuits in the panel are double lugged. (they have more than one electrical conductor attached to them) These circuits should be separated with individual protection to eliminate possible overloading and power outage.

Condition: Double tap

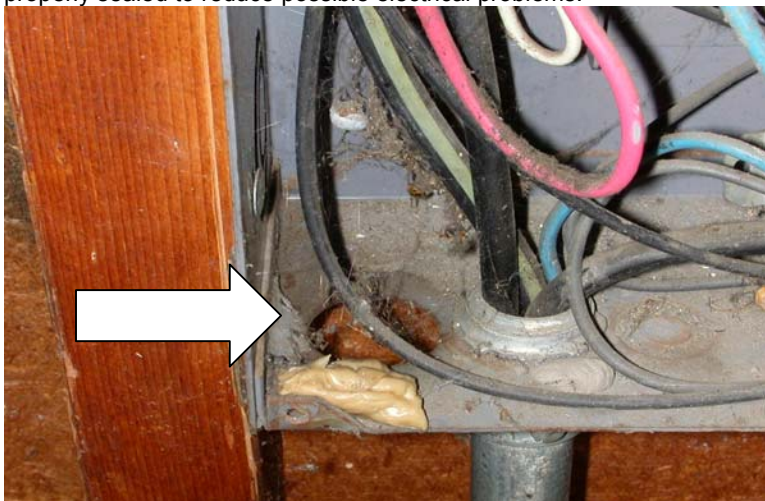
Open knockout --- Knockouts are open in the service panel. All knockouts should be properly sealed to reduce possible electrical problems.

Condition: Open knockout

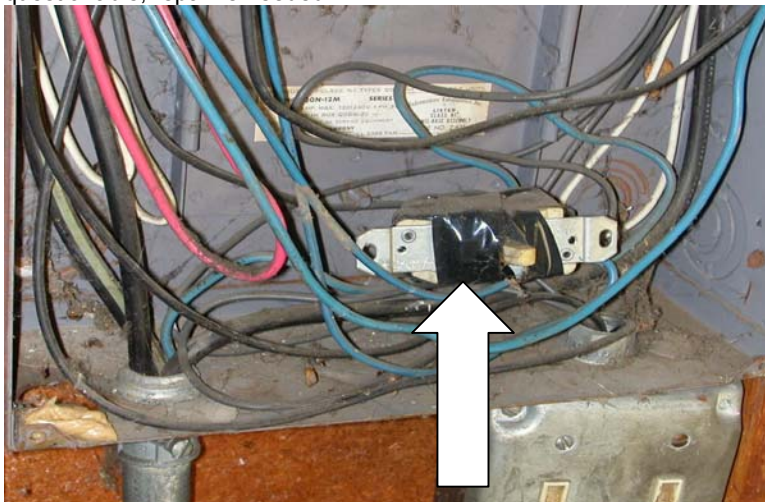
Improper splice --- Improper splicing was noted. Electrical continuity could be questionable, repair is needed.

Hazardous

Condition: Improper splice

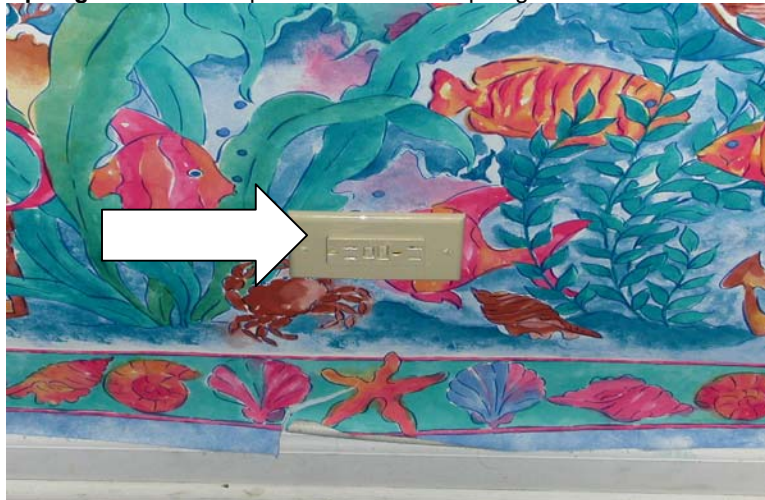
Conditions: **Open ground** --- Receptacle indicates an open ground and should be corrected.

Rating: **Hazardous**

Condition: Open ground

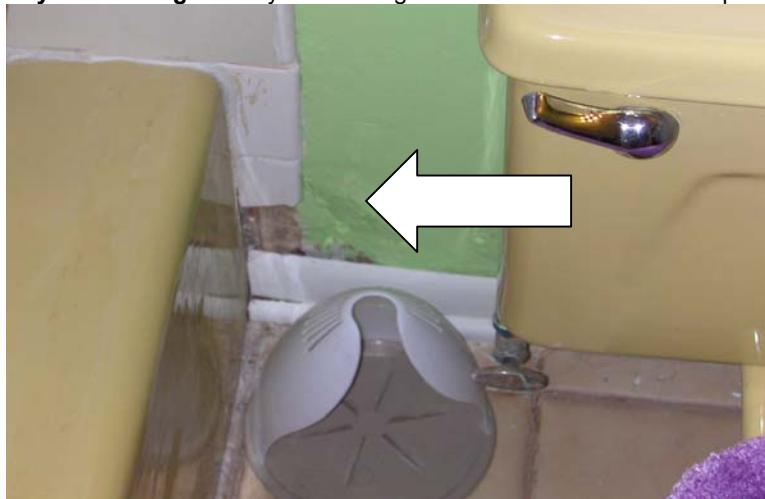
Tub/Shower: Tub, Shower
Conditions: **Physical damage** --- Physical damage was noted and should be repaired.

Rating: Defective

Condition: Physical damage

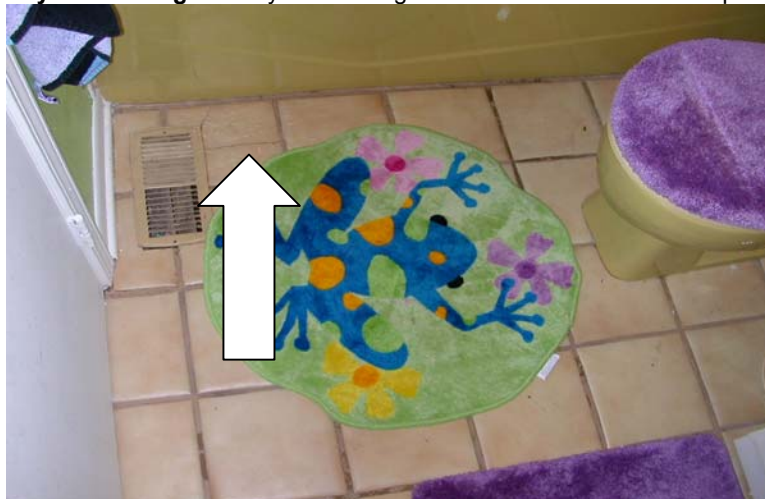
Floor: Ceramic tile
Conditions: **Physical damage** --- Physical damage was noted and should be repaired.

Rating: Minor Defect

Condition: Physical damage

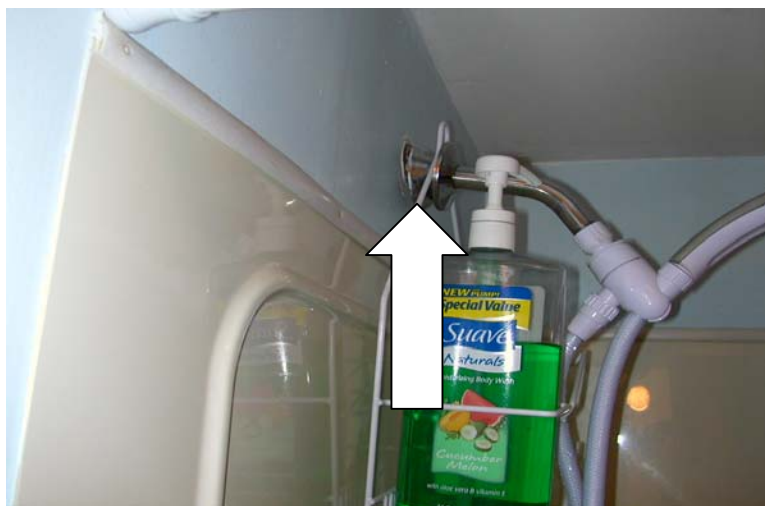
Tub/Shower: Tub, Shower
Conditions: **Loose shower head** --- The shower head is loose and should be repaired.

Rating: Minor Defect

Condition: Loose shower head
